# LAKE BUENA VISTA RESORT VILLAGE & SPA

## ACCESSIBILITY STATS

### Lake Buena Vista Resort Village & Spa

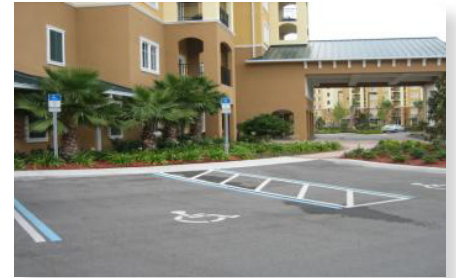
### CAR PARK(ING)

- NO obstacles are present to impede 100% accessibility by guests with mobility or visual difficulties.
- Car Park consists of a flat, evenly paved surface and surrounds resort allowing close and easy access to reception, guestrooms & resort facilities.
- Located directly in front of the reception building, four parking bays, one on each side of the reception building are designated, signed and painted for handicap parking only.
- Each building housing guestrooms also have two plus dedicated parking stalls.

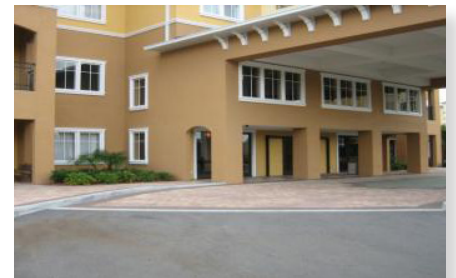
### HOTEL ENTRANCE & GROUNDS

- Main entrance and overall hotel ground of hotel is flat, consistent and even to that of the carpark.
- Entrance has manual opening door doors with a 69 inch width allowing access for wheelchairs and guests.
- Main entrance to hotel is flat, consistent and even to that of the car park and main entrance, converting from pavement to that of smooth and even surface progressing into that of tile flooring.

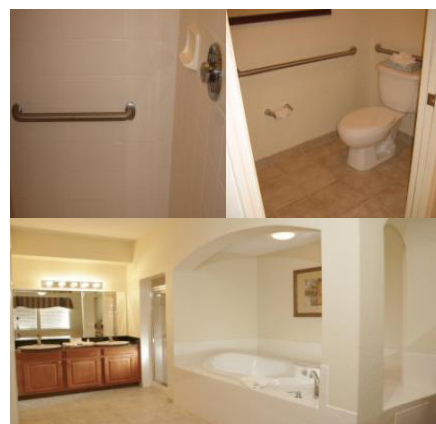
## APARTMENT BATHROOM

- Bathroom is open to that of the sleeping area – en suite to master bedroom
- 50 inches–Width of Bathroom Entrance Door from Bedroom, Bath Tub & Shower
- 17 inches – Toilet Height from floor to top of seat
- 27 inches – Bath Tub Height from floor to top of tub
- 34 inches – Sink Height from floor to top of sink surround
- NO – Wheelchair cannot access side of toilet or fit under sink
- YES – Wheelchair can access side of bath tub, front of toilet and shower
- YES – Wheelchairs can access bathroom and maneuver – with assistance.
- NO – Grab rails are present alongside the bath. YES – grab rails are present in shower.
- YES – Grab rails are present alongside the toilet at 33" from ground.
- NO & YES – Bath seat are not a fixture of the bath. However, seats are available upon request and subject to availability.

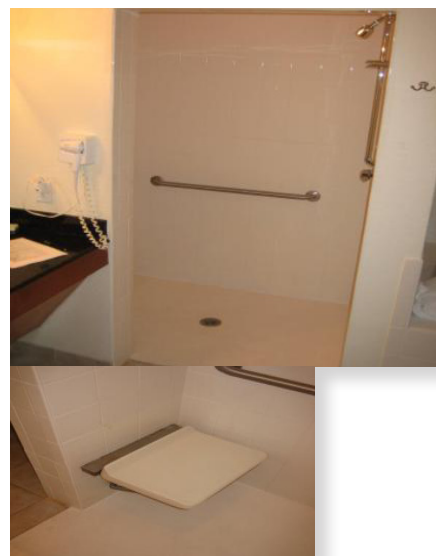
## ROLL-IN SHOWER ACCESSIBLE APT

- Apartment is considered as a fully handicap accessible – roll-in shower – master bedroom en suite bathroom. Apartments, Location and Bed Type:
- 2 Bedroom Apartments
  - Building 1, third floor – 1311
  - Building 3, 5th floor – 3508, sixth floor – 3608, tenth floor 31008
  - Building 4, third floor – 4305
  - Building 5, 5th floor 5506, 6th floor 5606, 10th floor 51006, 14th floor 51406
- 3 Bedroom Apartments
  - Building 1, third floor – 1302
  - Building 2, ground floor - 2102 & 2109
  - Building 3, eighth floor – 3814, twelfth floor – 31214
  - Building 5, 3rd floor 5301, 4th floor 5401, 8th floor 5801, 12th floor 51201, 15th floor 51501
- 8 inches - Beds/Mattress are situated above ground on a solid metal frame
- 34 inches – Entrance Door Width and Bedroom Door Width
- 26 inches – Height of bed from ground to top of mattress

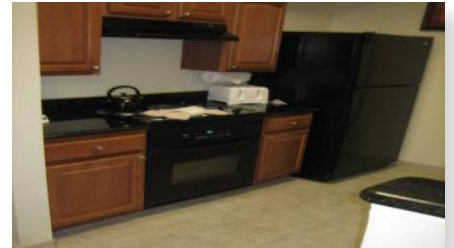
## FULLY ADAPTED KITCHEN

- 34 inches – Height from floor to counter top – kitchen sink
- 35 inches – Height from floor to stove top – 4 rings
- 34 inches – Height from floor to counter top – microwave oven access
- 52" inches – Width for access from living area, hallway to kitchen – carpet to tile
- YES – All apartments have refrigerators

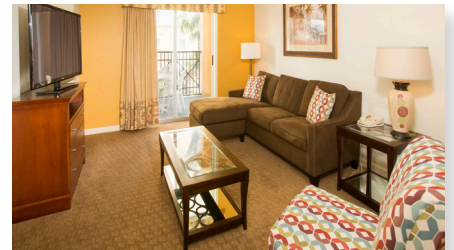
## STANDARD APT

- Apartments are located on ground to fourteenth floor
- 34 inches – Width of entrance to apartment
- 34 inches – Width of bathroom door – in all standard bathroom (not master)
- YES - Hotel has standard apartment located on the ground floor
- Ground floor apartments are consider as run of house – ground floor
- YES – All apartments have refrigerators

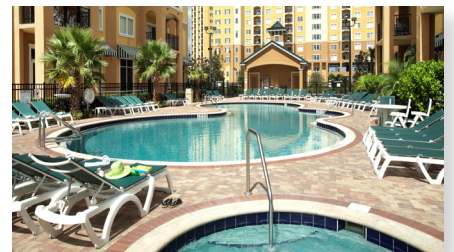
## SWIMMING POOL

- Two Swimming pools are accessible through gate, flat, paved surface.
- YES – Pool access has either shallow zero entry or steps with railing or ladder with grab rails
- No – Pool does not have a hoist to accommodate disabled guests
- YES – Jacuzzi at main pool has a hoist to accommodate disabled guests
- YES – Pool area is easy accessible to guests with disabilities

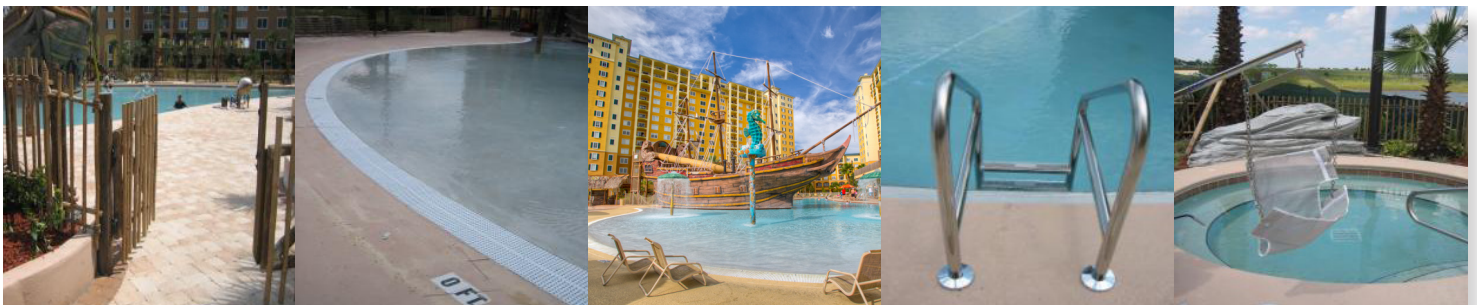
## AQUATIC CENTER – MAIN RESORT POOL

Entrance

Zero Entry  
Access

Zero Entry –  
towards main  
area

Stairs to  
depend

Lift for Jacuzzi  
access
